STREAM RESTORATION AT NEWELL CREEK:

# A HEALTHIER FUTURE FOR OUR NEIGHBORHOOD

### STREAM RESTORATION AT NEWELL CREEK

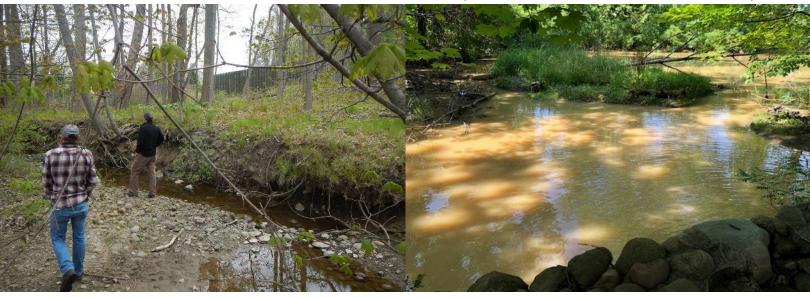
## BEFORE RESTORATION: INCISED STREAM CHANNEL

This photo shows the deeply incised stream channel prior to restoration efforts. The banks were unstable, and erosion was evident.

The pond area was heavily filled with sediment, disrupting natural stream function and limiting habitat for aquatic life.

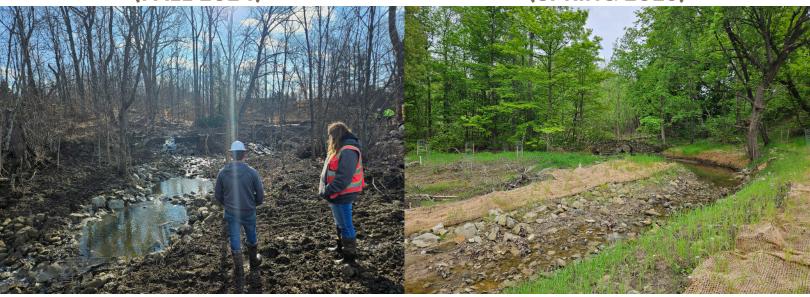
# DURING CONSTRUCTION (FALL 2024)

This photo, taken during construction, shows the newly constructed step pools. The cut dam can be seen in the center left. After construction water no longer flowed through the dam pool except during high flow events. The stream was rerouted around the dam to the west (center right).

This photo, taken shortly after construction, shows the newly restored stream bank. Erosion control fabric and native seed mixes were installed to stabilize the bank and promote healthy vegetation. Herbaceous plugs, trees, and livestakes were also installed. The footbridge can be seen in the background.
